Manhole Inspection Summary

Manhole # S35S__034MH

Insp Date: **11/25/08 11:44 AM**

Location Address: **rear 106 pilgrim landing**

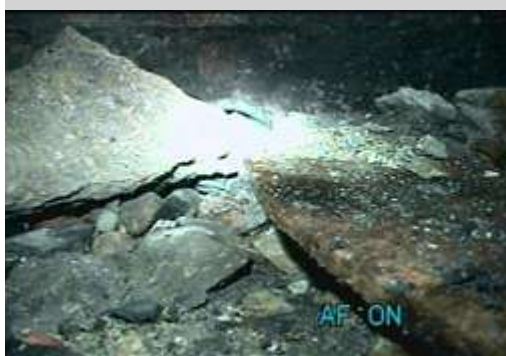
Defect 3

Condition: ☐ Sound ☐ Cracked ☐ Root Intrusion ☐ Deteriorated ☐ Leaks ☒ **Debris**

channel debris

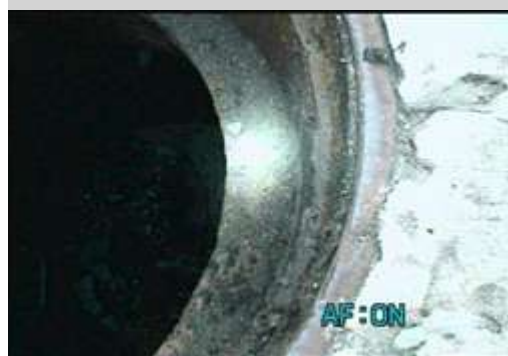
Defect 2

Offset: **3** (in.)

frame offset 3 inches

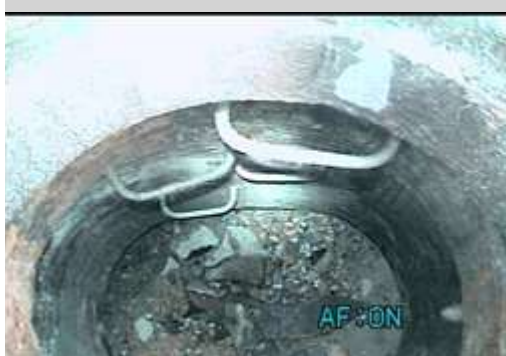
Defect 1

Count: **4** Missing: **0** ☒ **Corroded**

steps corroded

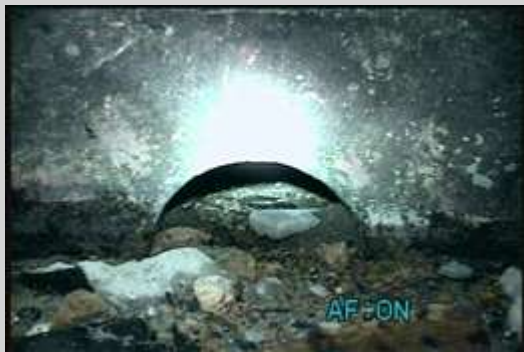
12 O'Clock Outflow

8 in. Circular Gravity Sewer
Pipe Out @ 12 O'Clock

Pipe Material: **Clay** ☐ Pipe Lined

Invert Depth: 7.33 (ft.) Flow Characteristics: **None**

Deposits: ☒ None ☐ Mud ☐ Sludge ☐ Debris ☐ Grease

Infiltration: **None** Pipe Seal Cond: **Unknown**
